Accessibility Audit

Alexandra Primary School

Denbigh Rd

Date 13/03/2019

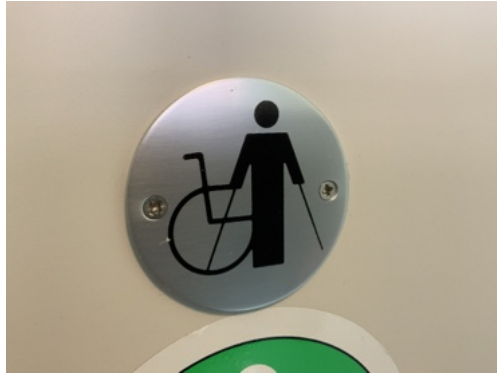
Photo 70

15.3	There is no tactile or braille signage provided on the toilet doors. The existing signage n the accessible WCs is dated and should be replaced.	The appropriate toilet signage should be provided as part of the recommended way finding review, refer to 15.1	M

15.3 - Are standard toilet facilities suitably signed? On approach and on the actual entrances? Are the locations of the accessible WC facilities suitably identified and located? Does signage have the International Symbol of Access? (Wheelchair symbol)	C	There is no tactile or braille signage provided on the toilet doors. The existing signage in the accessible WCs is dated and should be replaced.
  <p>Photo 70</p>
