Accessibility Audit

Alexandra Primary School

Denbigh Rd

Date 13/03/2019

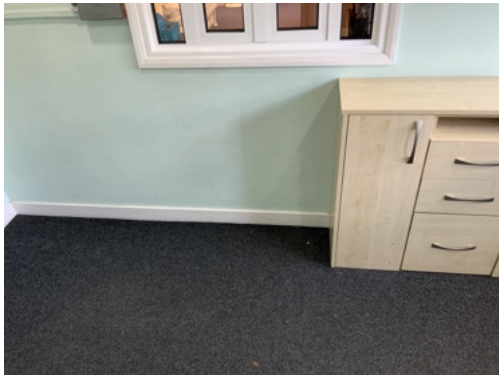
Photo 13

6.4 - Surfaces suitable? Is there colour contrast to the flooring in front of the reception desk and are edges highlighted?	D	The reception does not have colour contrast provided to the front flooring to aid people with impaired vision.
  <p>Photo 13</p>

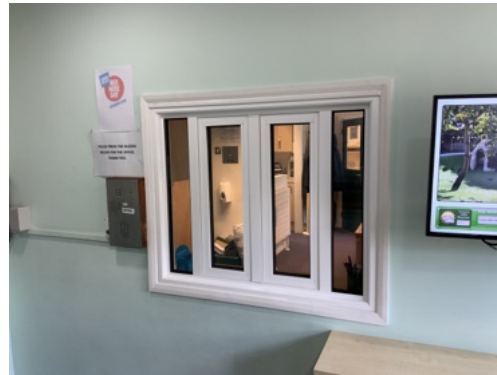
Photo 14

6.5 - Induction loop fitted? Is there signage indicating the availability of the facility? Are front line staff aware of the facility and its purpose?	A	There is no induction loop provided to the reception hatch to accommodate hearing aid users who struggle when there is background noise.
  <p>Photo 14</p>

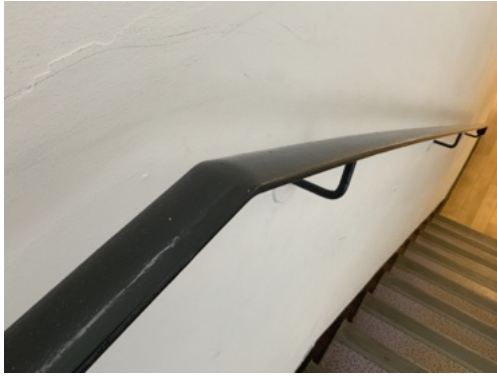
Photo 29

<div data-bbox="114 967 392 1246" data-label="Image"> </div> <p data-bbox="208 1262 297 1283">Photo 29</p> <div data-bbox="461 967 736 1246" data-label="Image"> </div> <p data-bbox="555 1262 645 1283">Photo 30</p> <div data-bbox="808 967 1084 1246" data-label="Image"> </div> <p data-bbox="902 1262 992 1283">Photo 31</p>		
<p>10.4 - Landings big enough and provided at intermediate levels in a long flight?</p>	<p data-bbox="1106 1353 1128 1374">D</p>	<p>Stairs do not have tactile warning surfaces to the top and bottom of the flights to accommodate people with impaired vision.</p>
